Milfoil Eradication in Walsh Lake

Josh Wozniak

Herrera Environmental Consultants

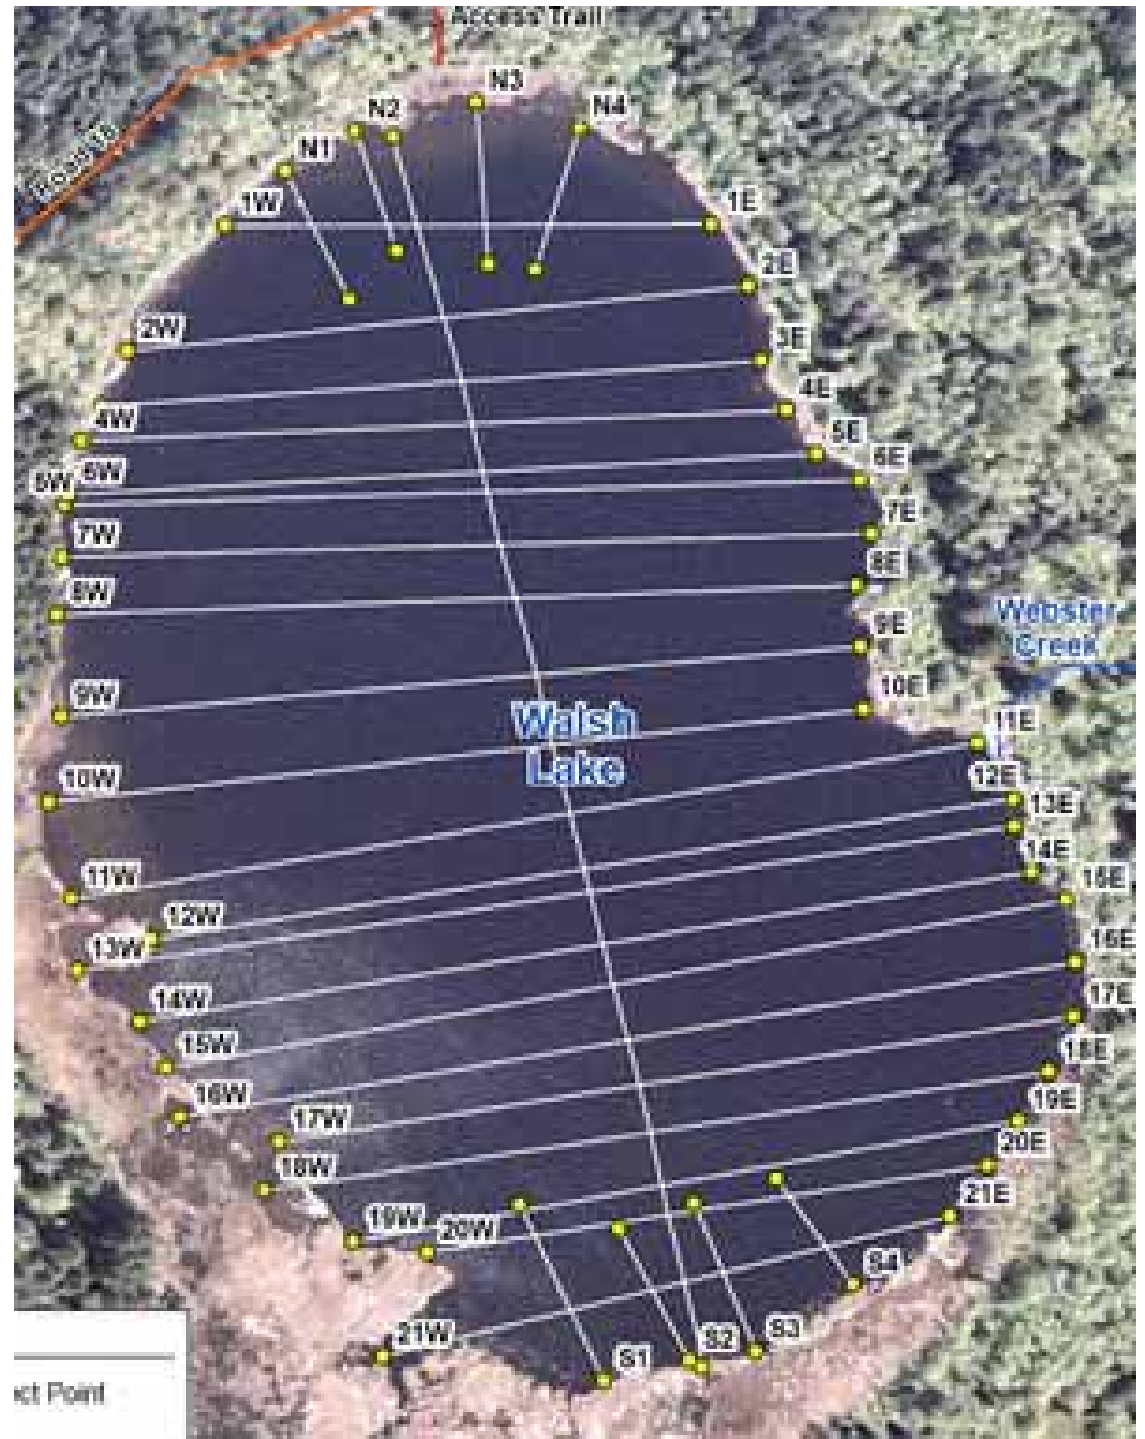
Mapping

Boat survey, viewer, rake sampling, and fathometry.

- Determine extent of milfoil and other weeds.
- Develop bathymetric map.

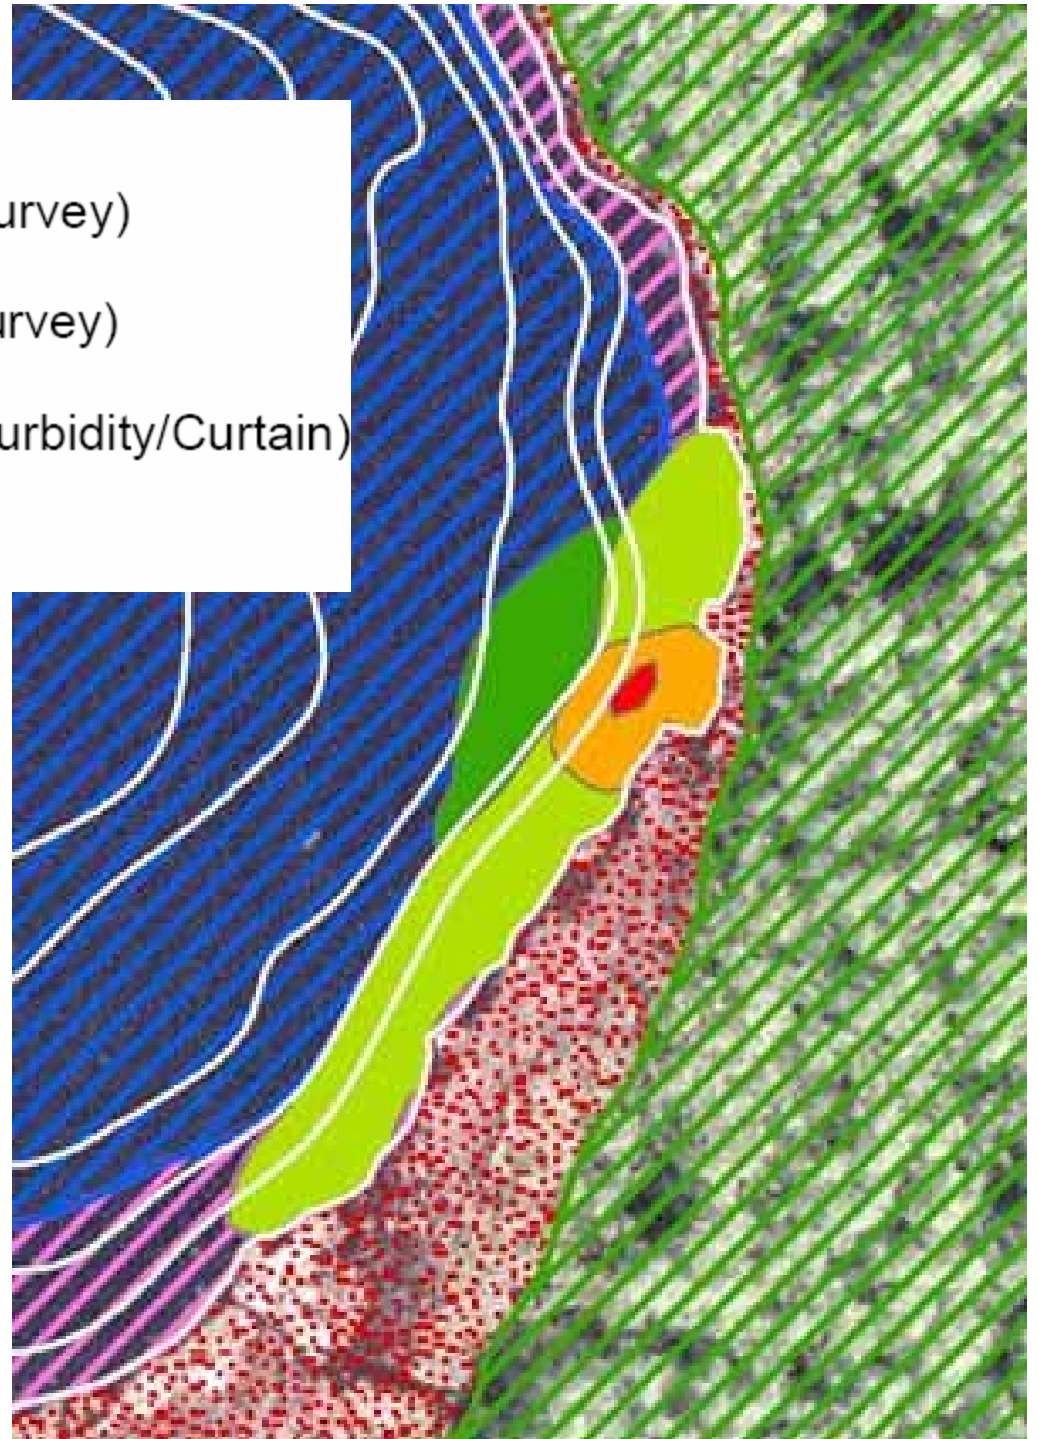
Eurasian Watermilfoil

Milfoil !

And a white water lily too.

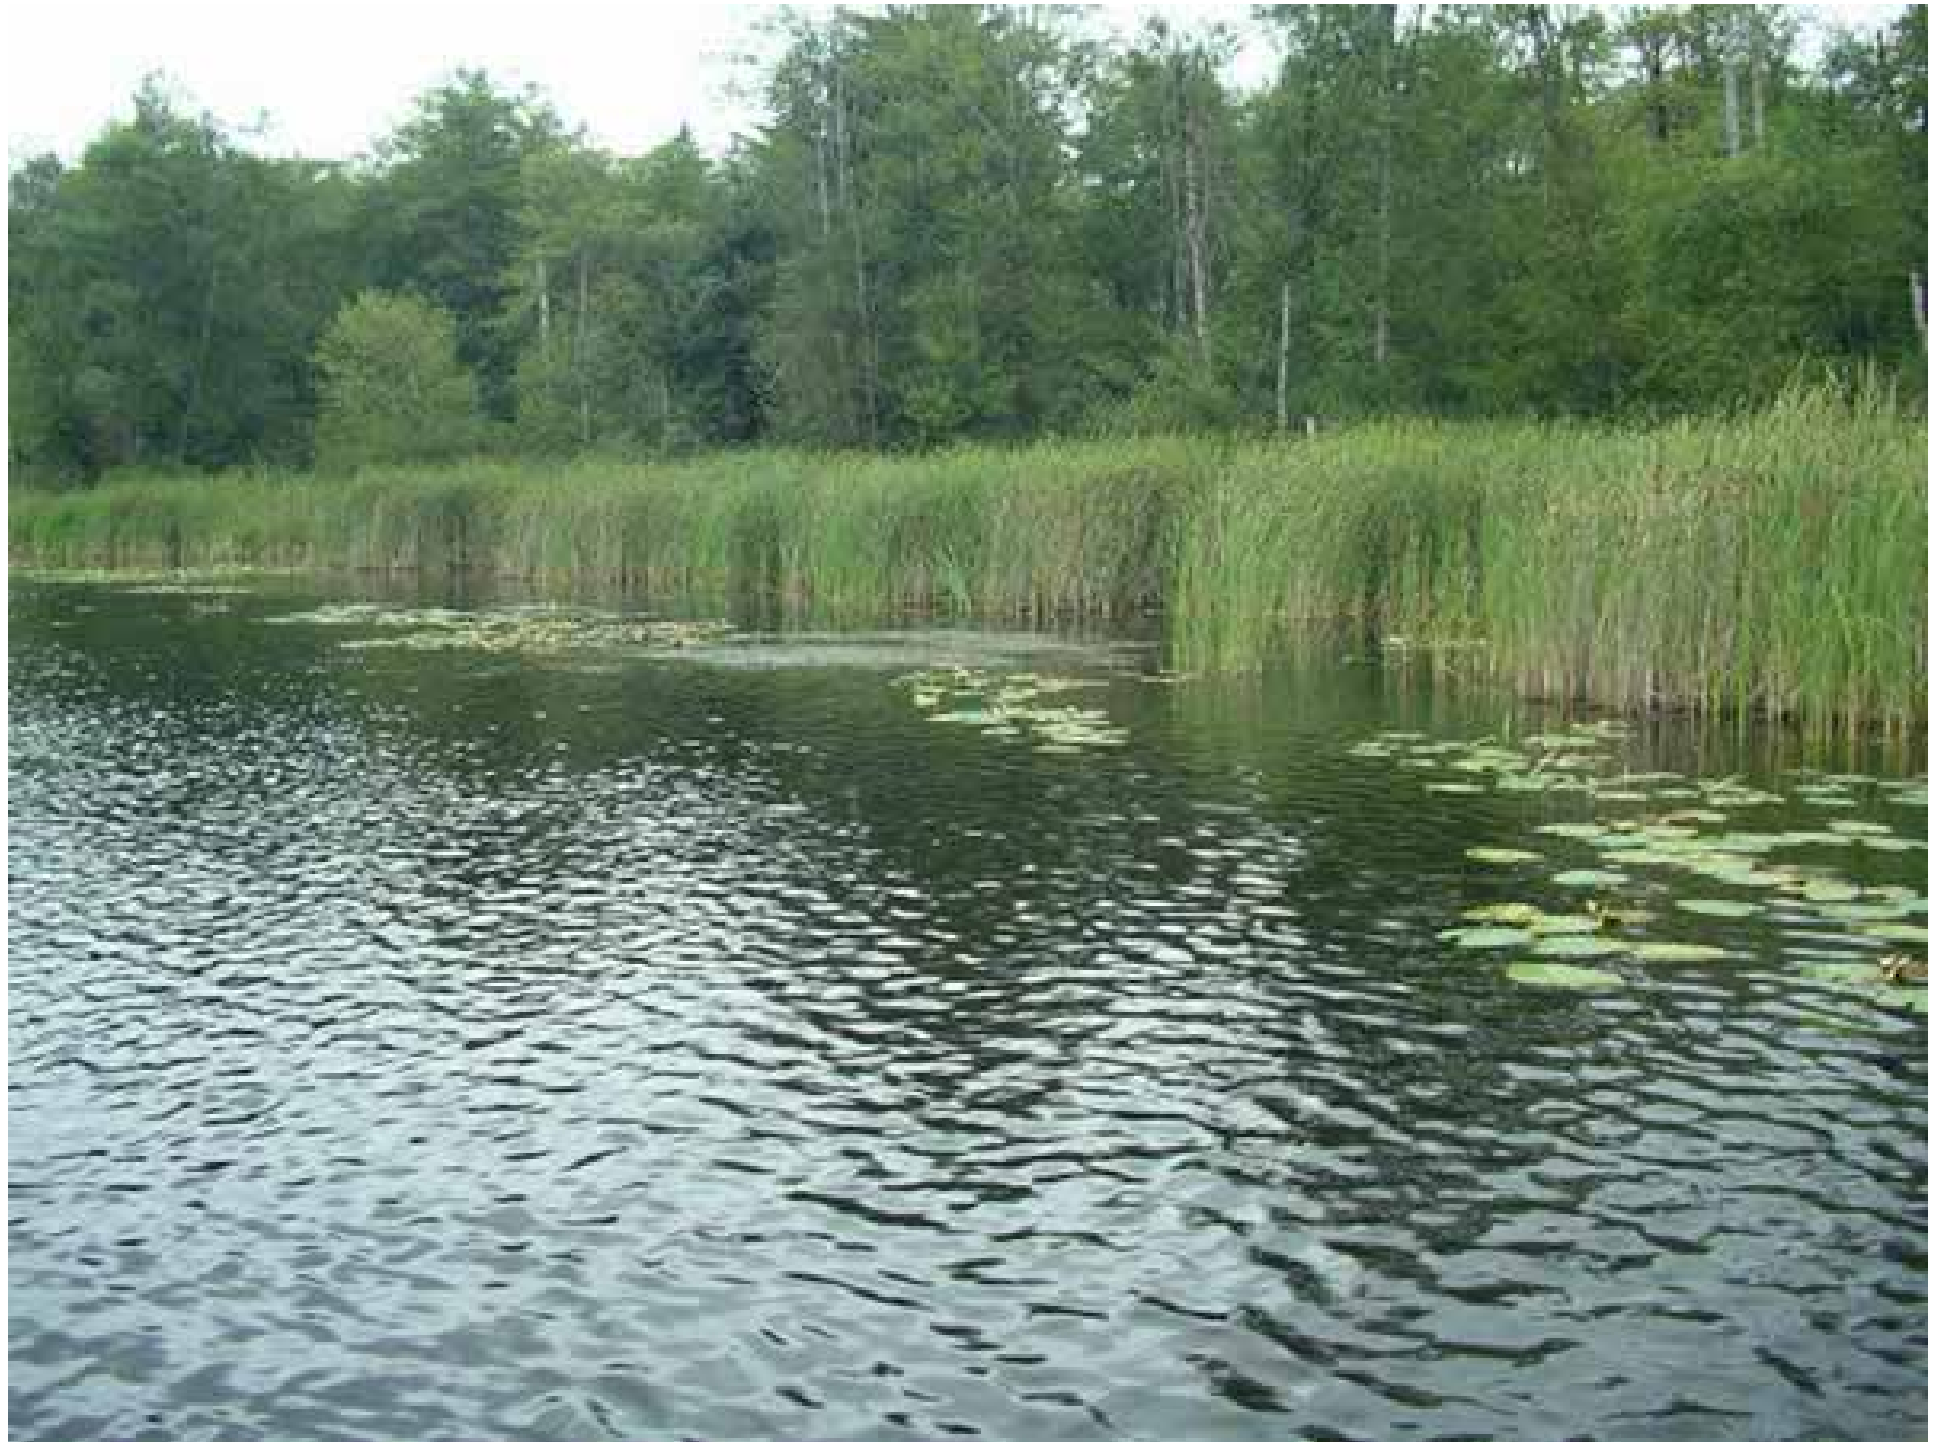
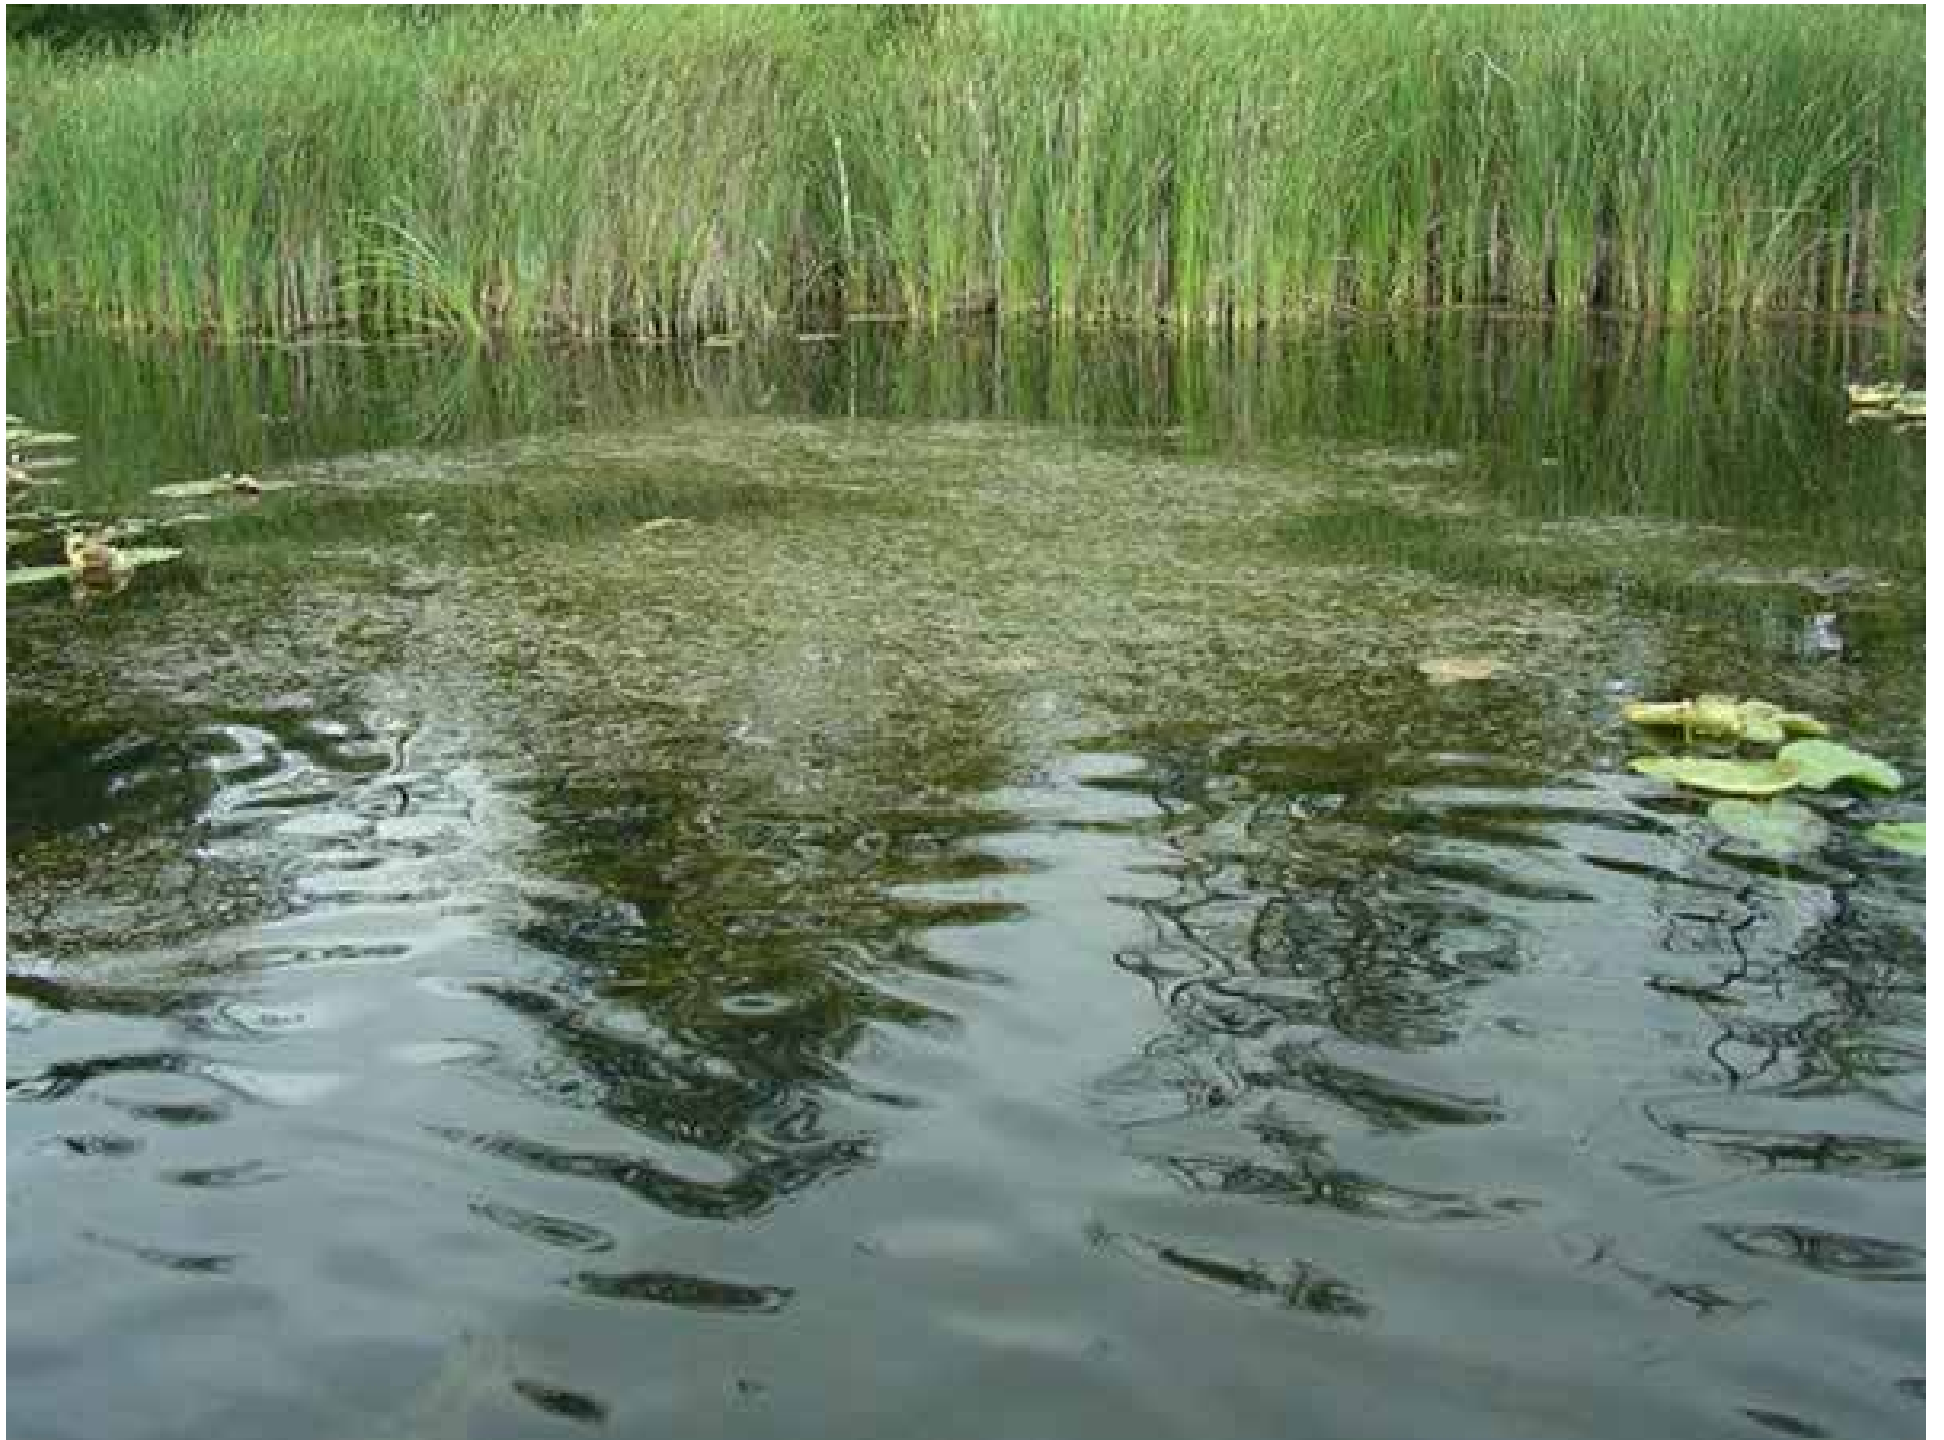
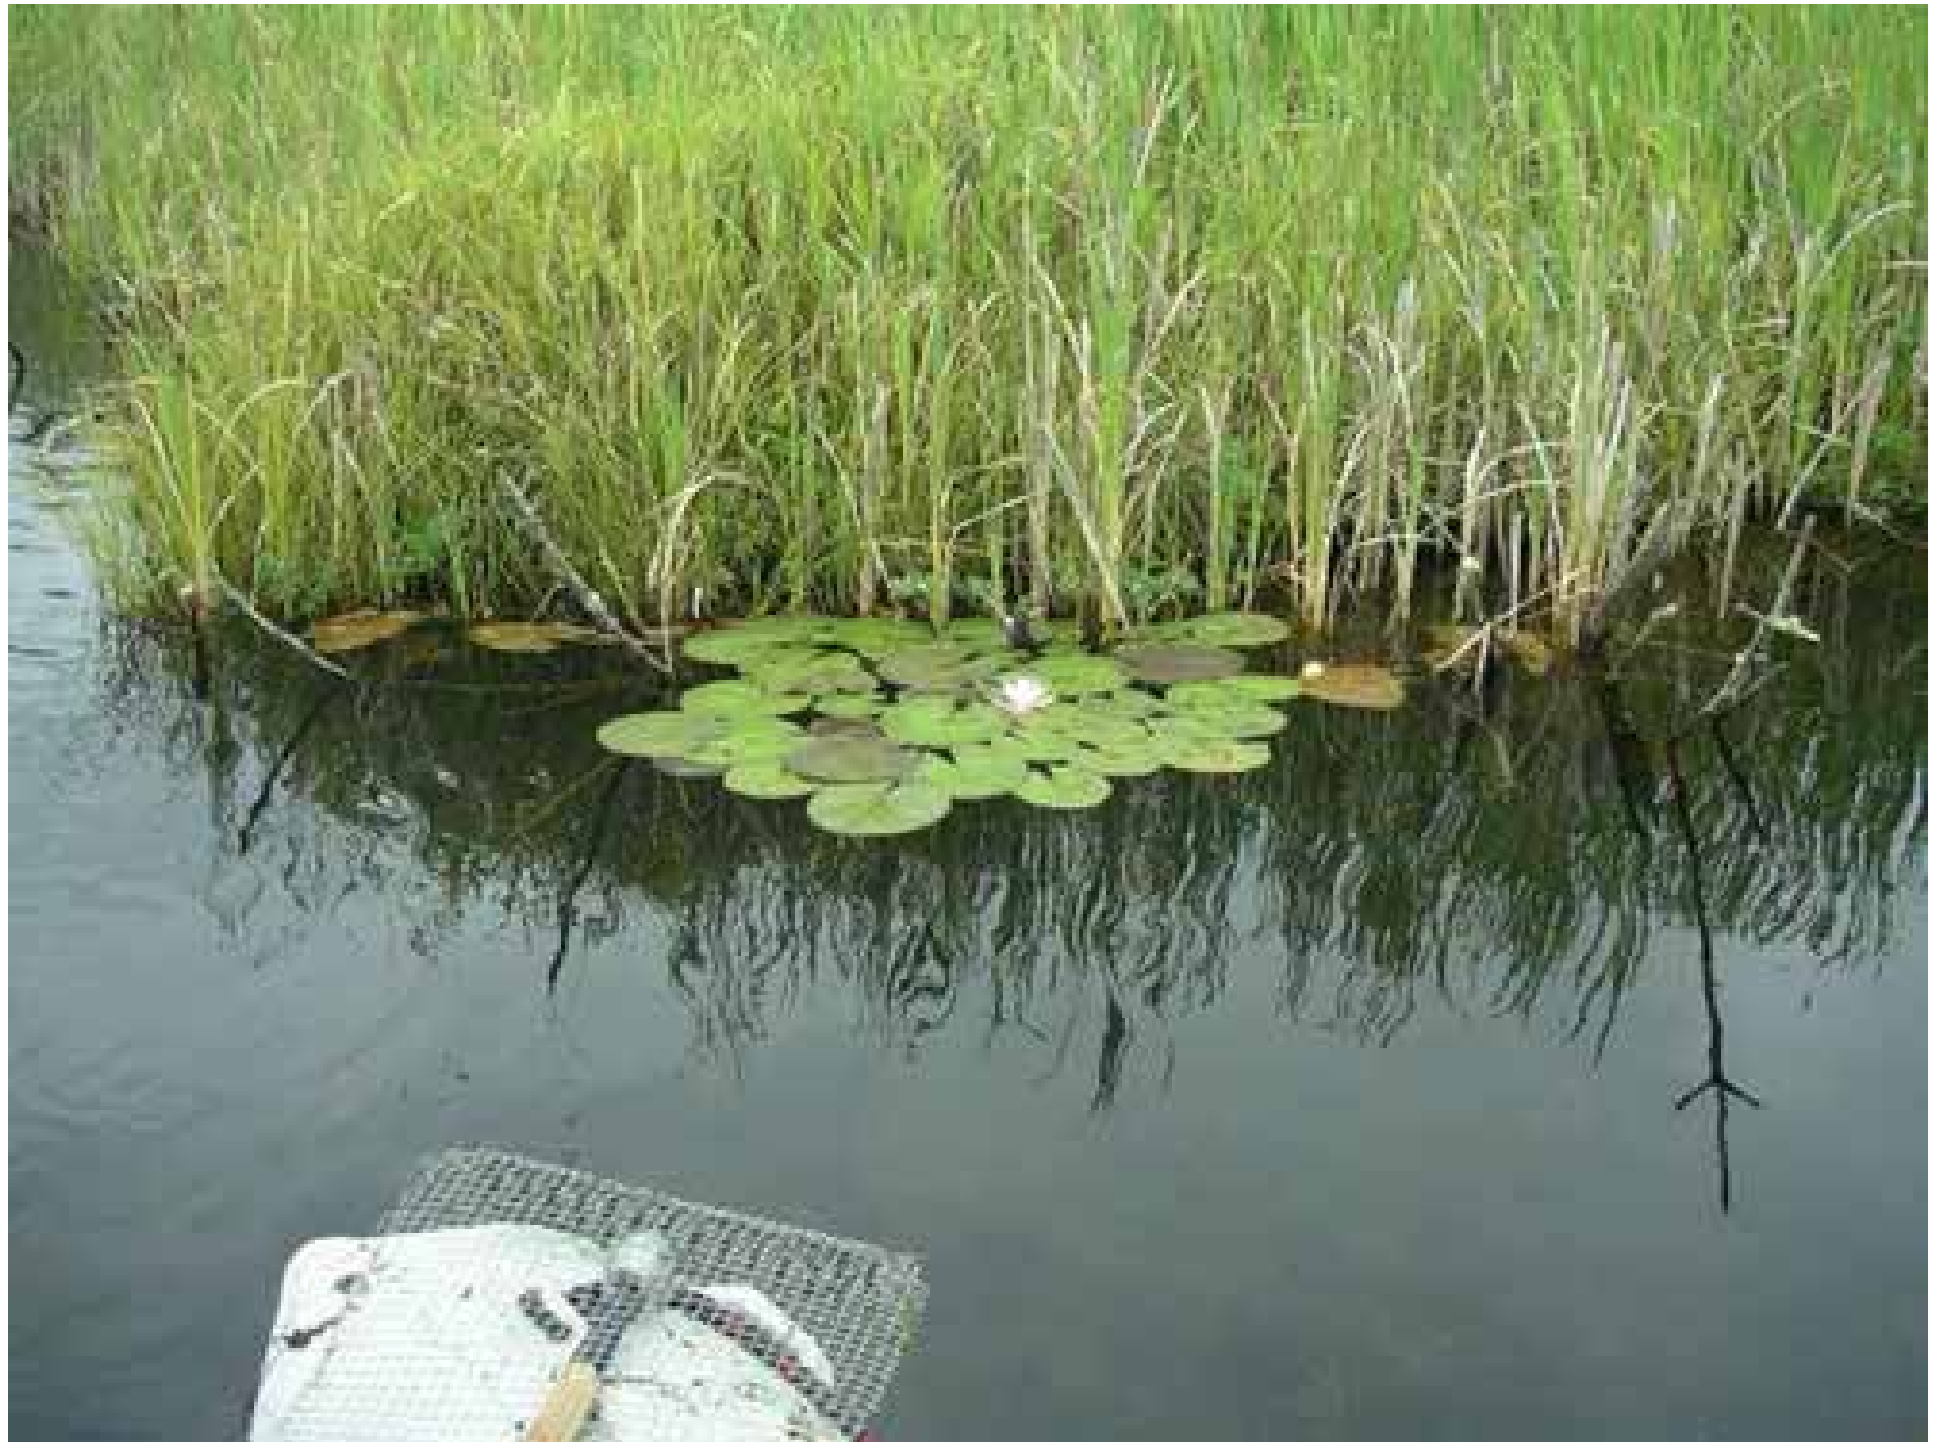
122 Native plant species.

26 native floating and submerged species.
