Milfoil Eradication in Walsh Lake

Josh Wozniak

Herrera Environmental Consultants

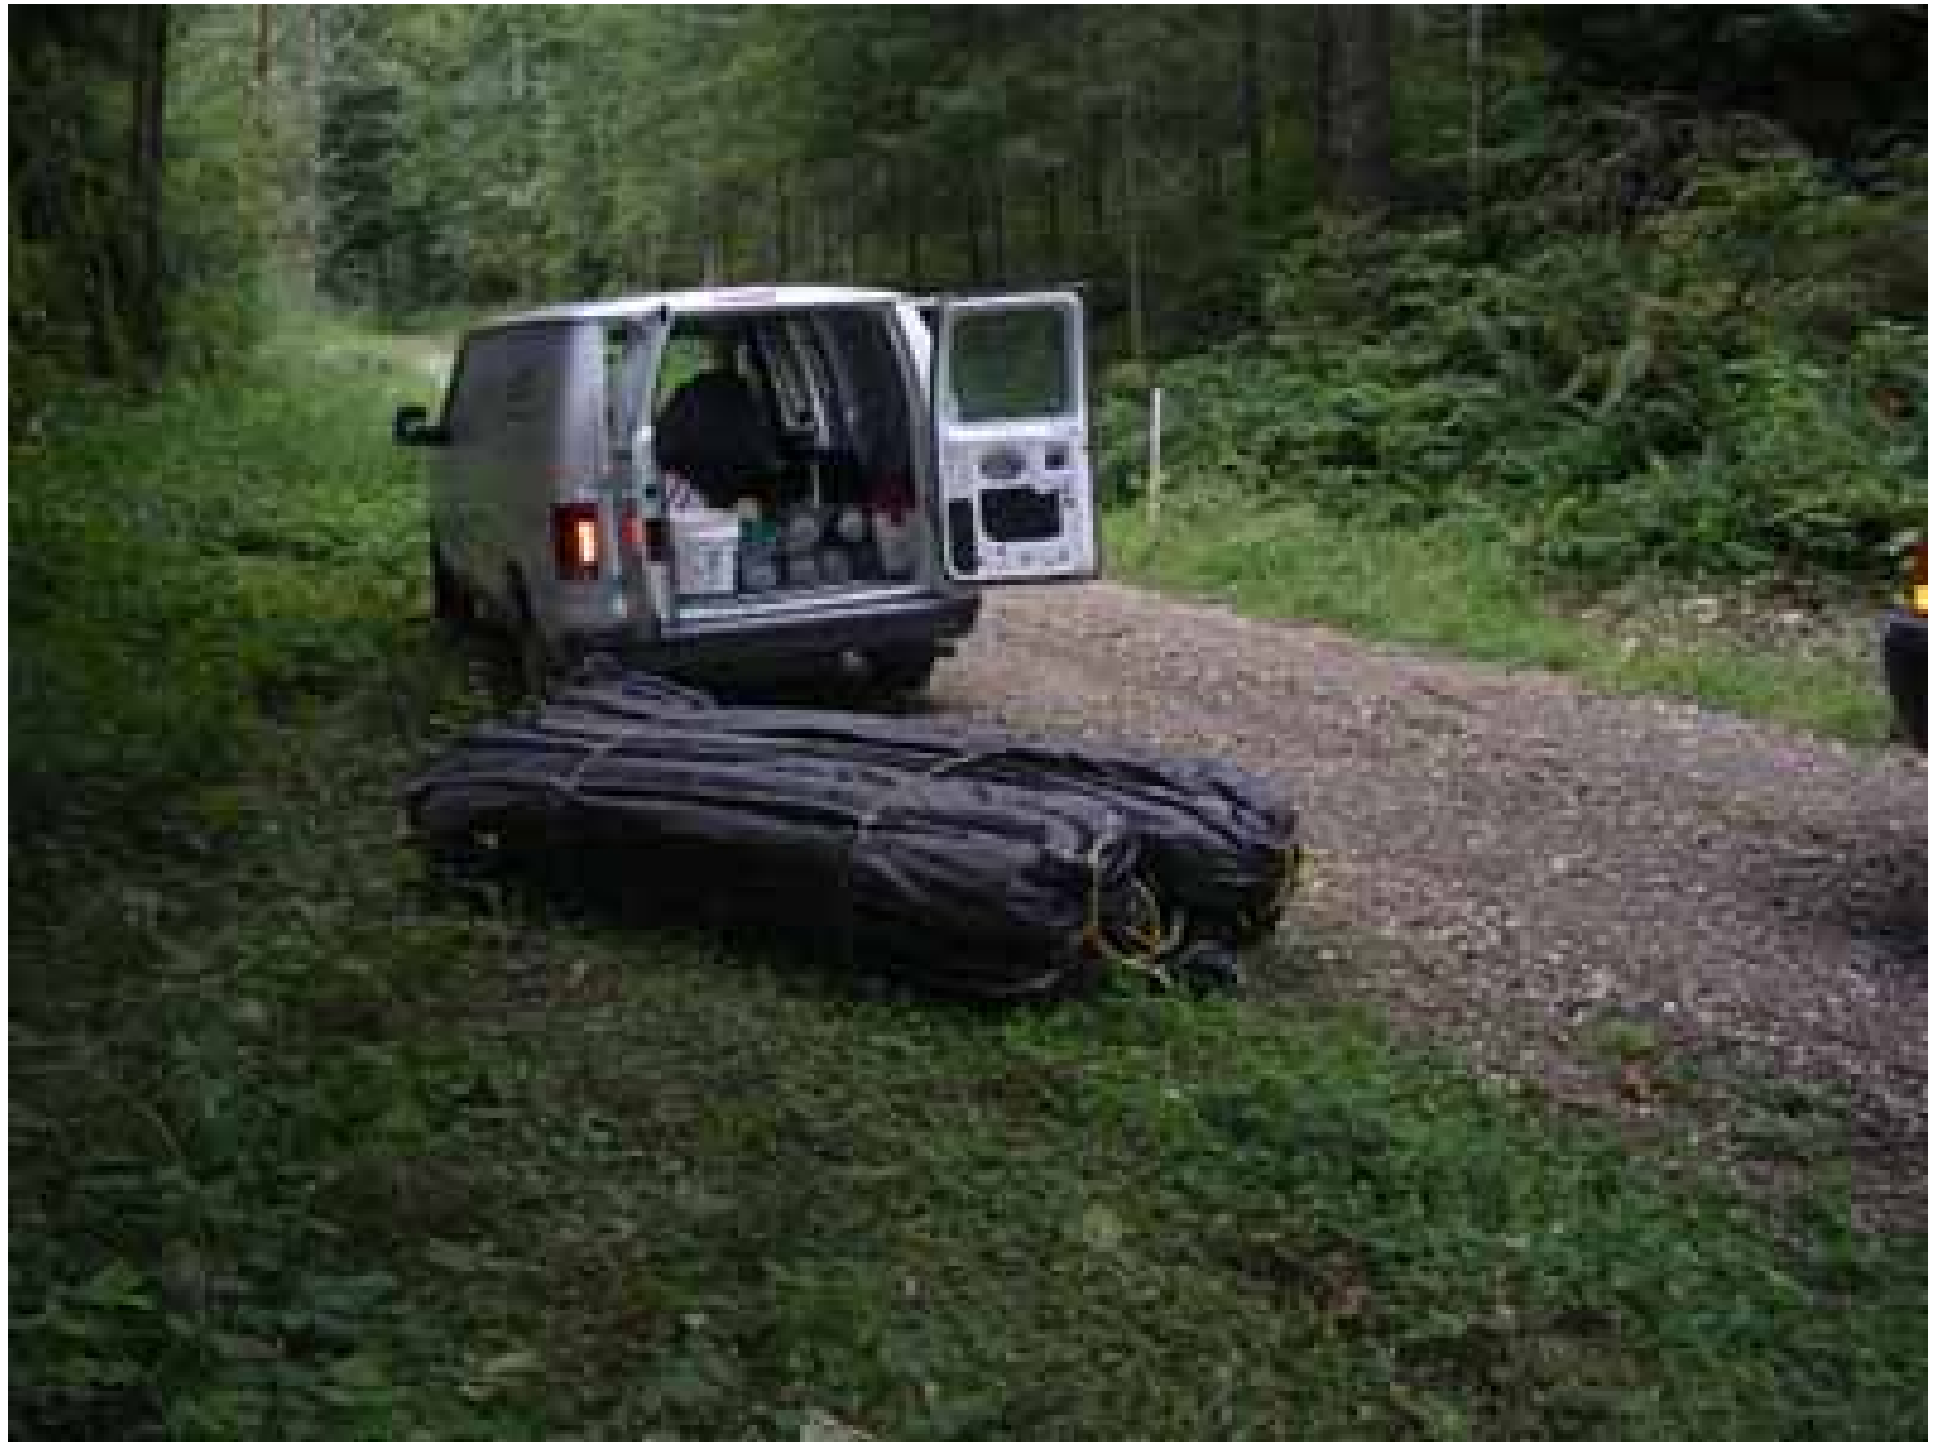
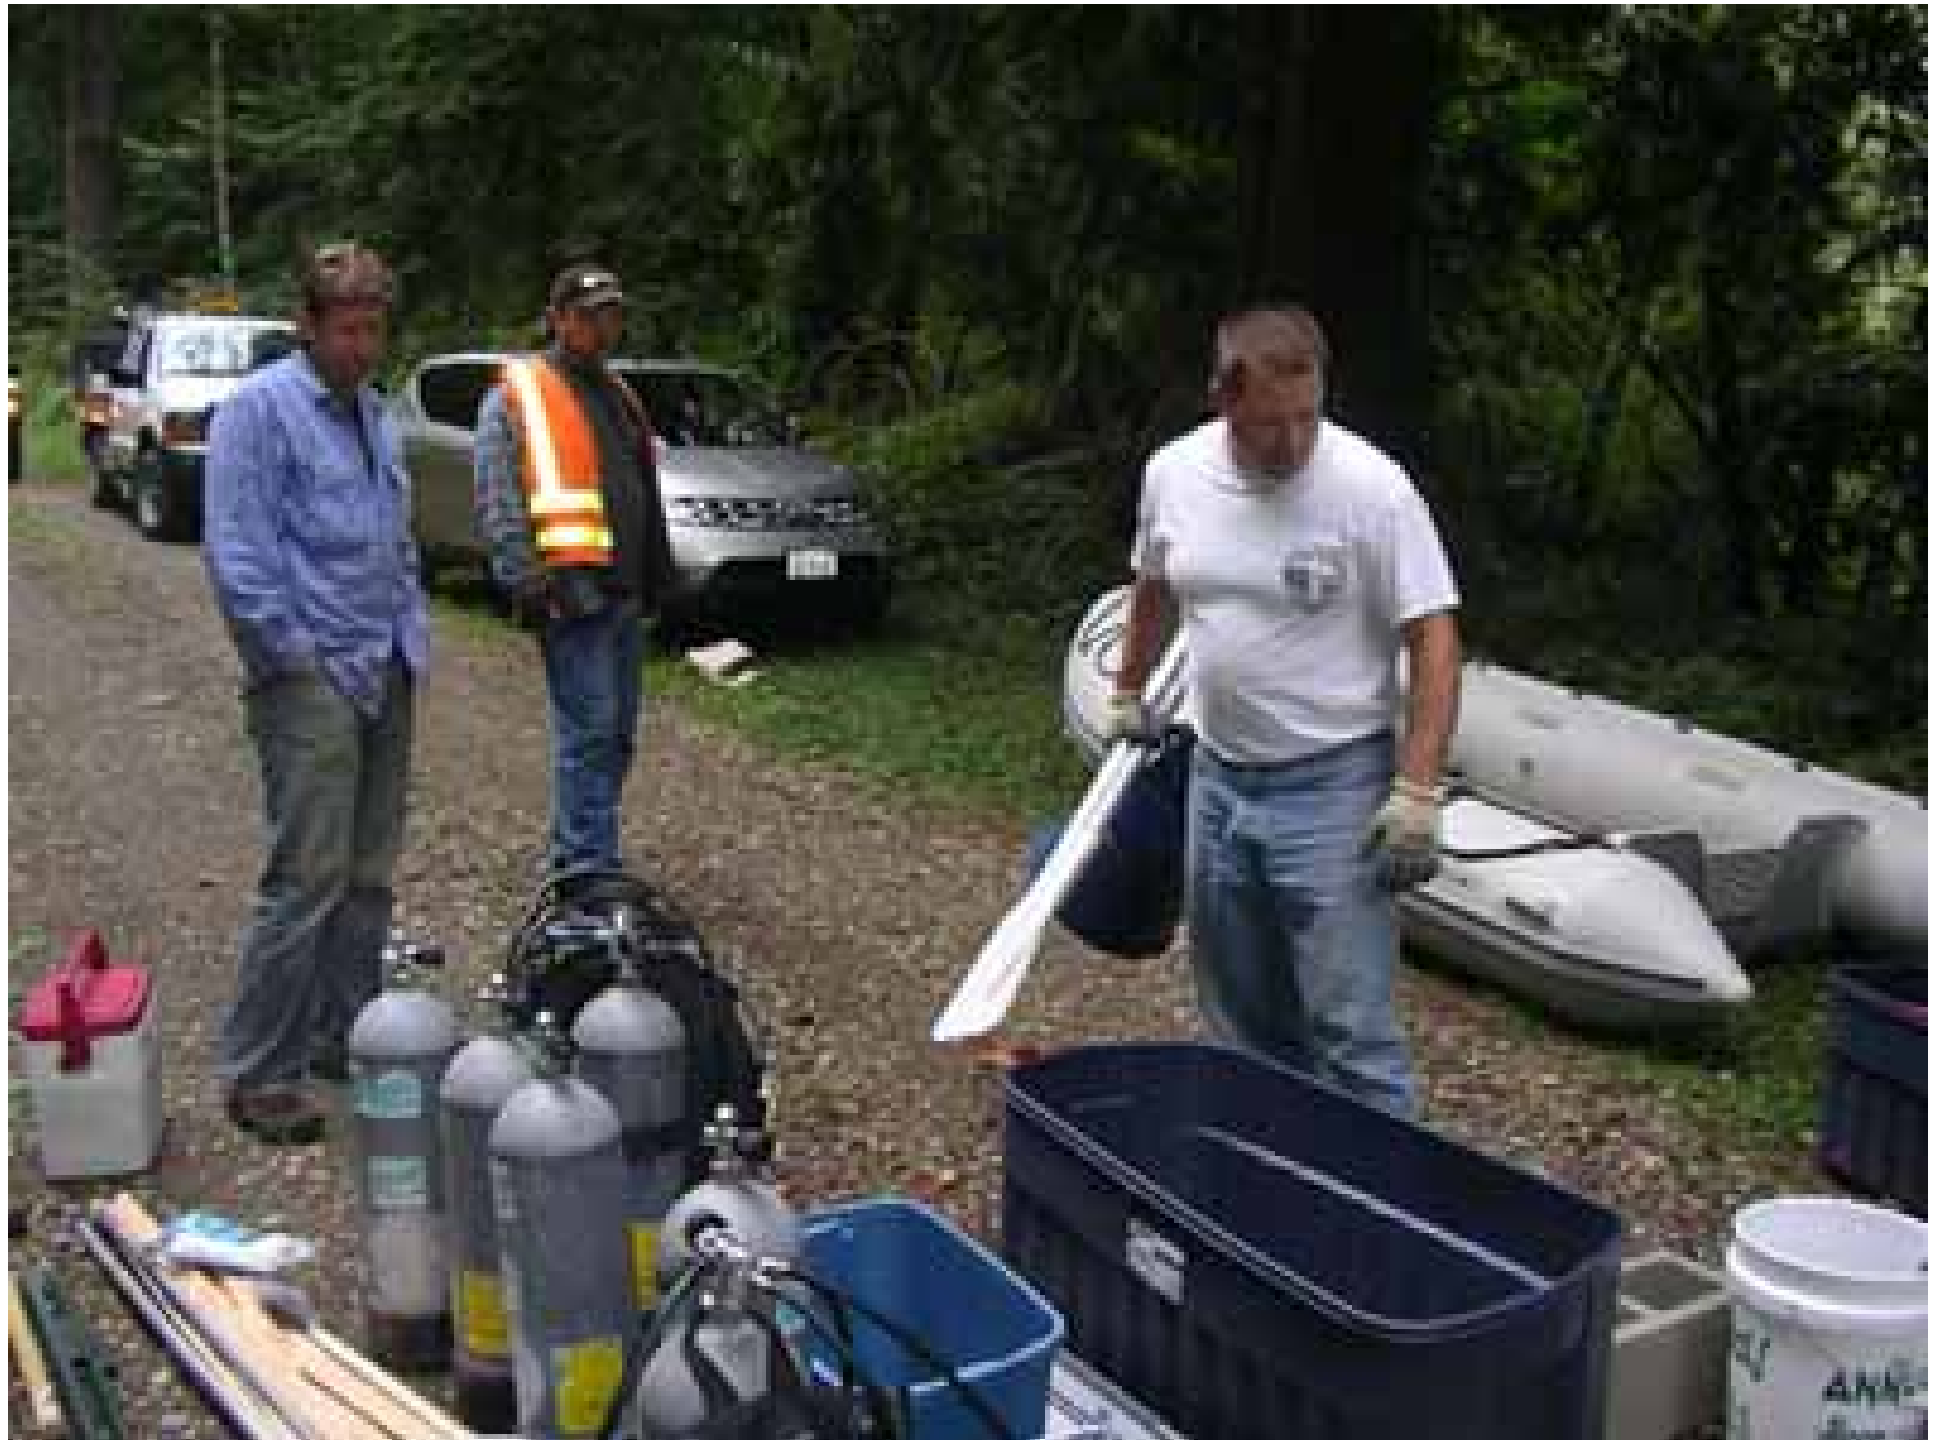
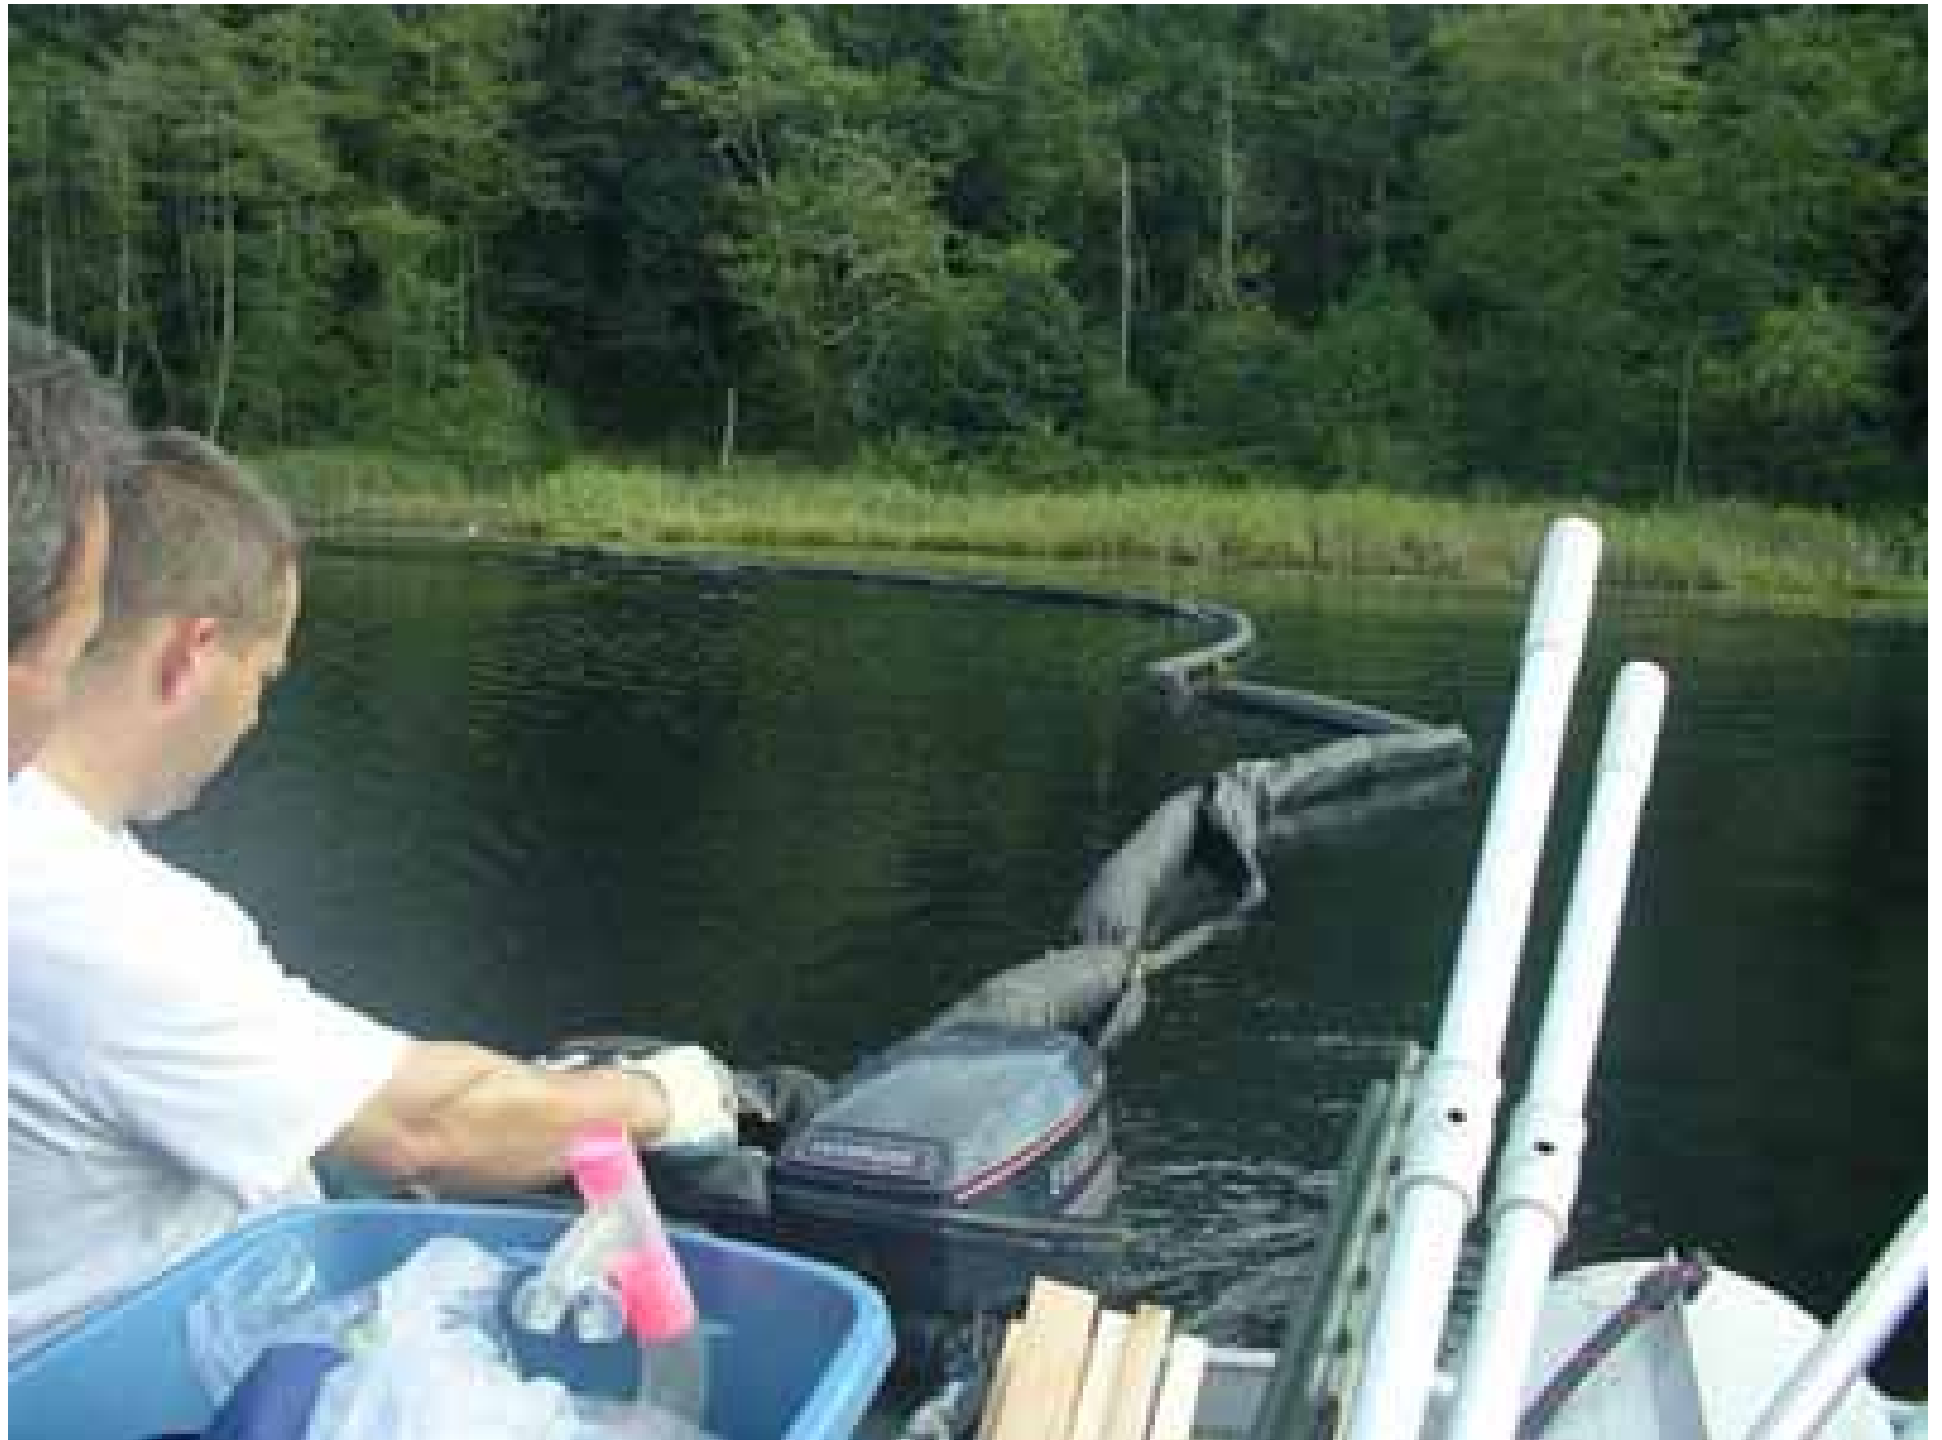
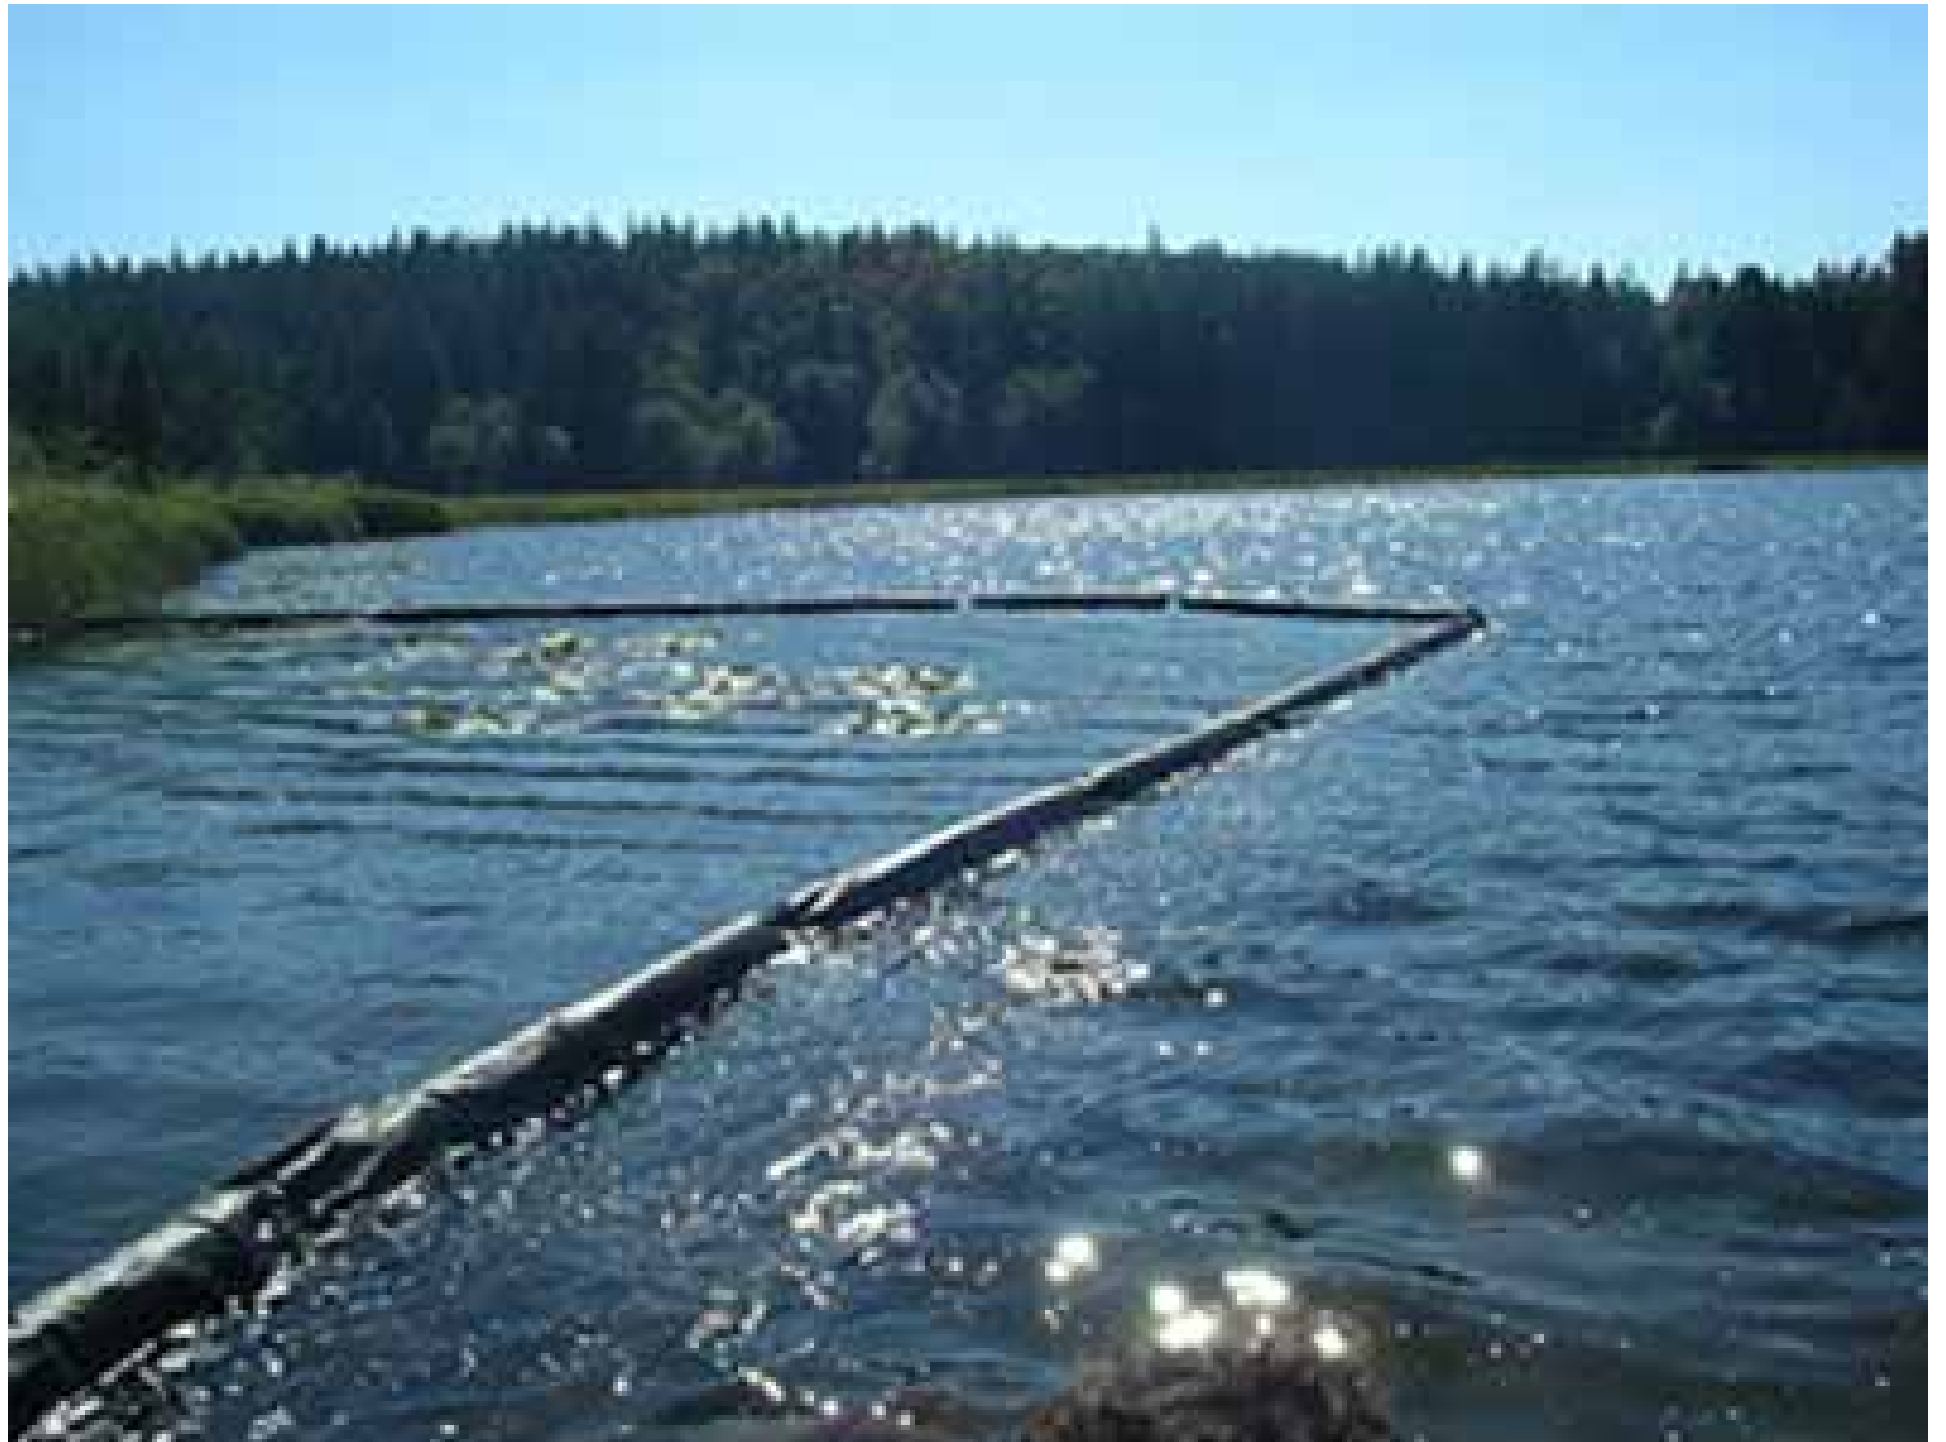
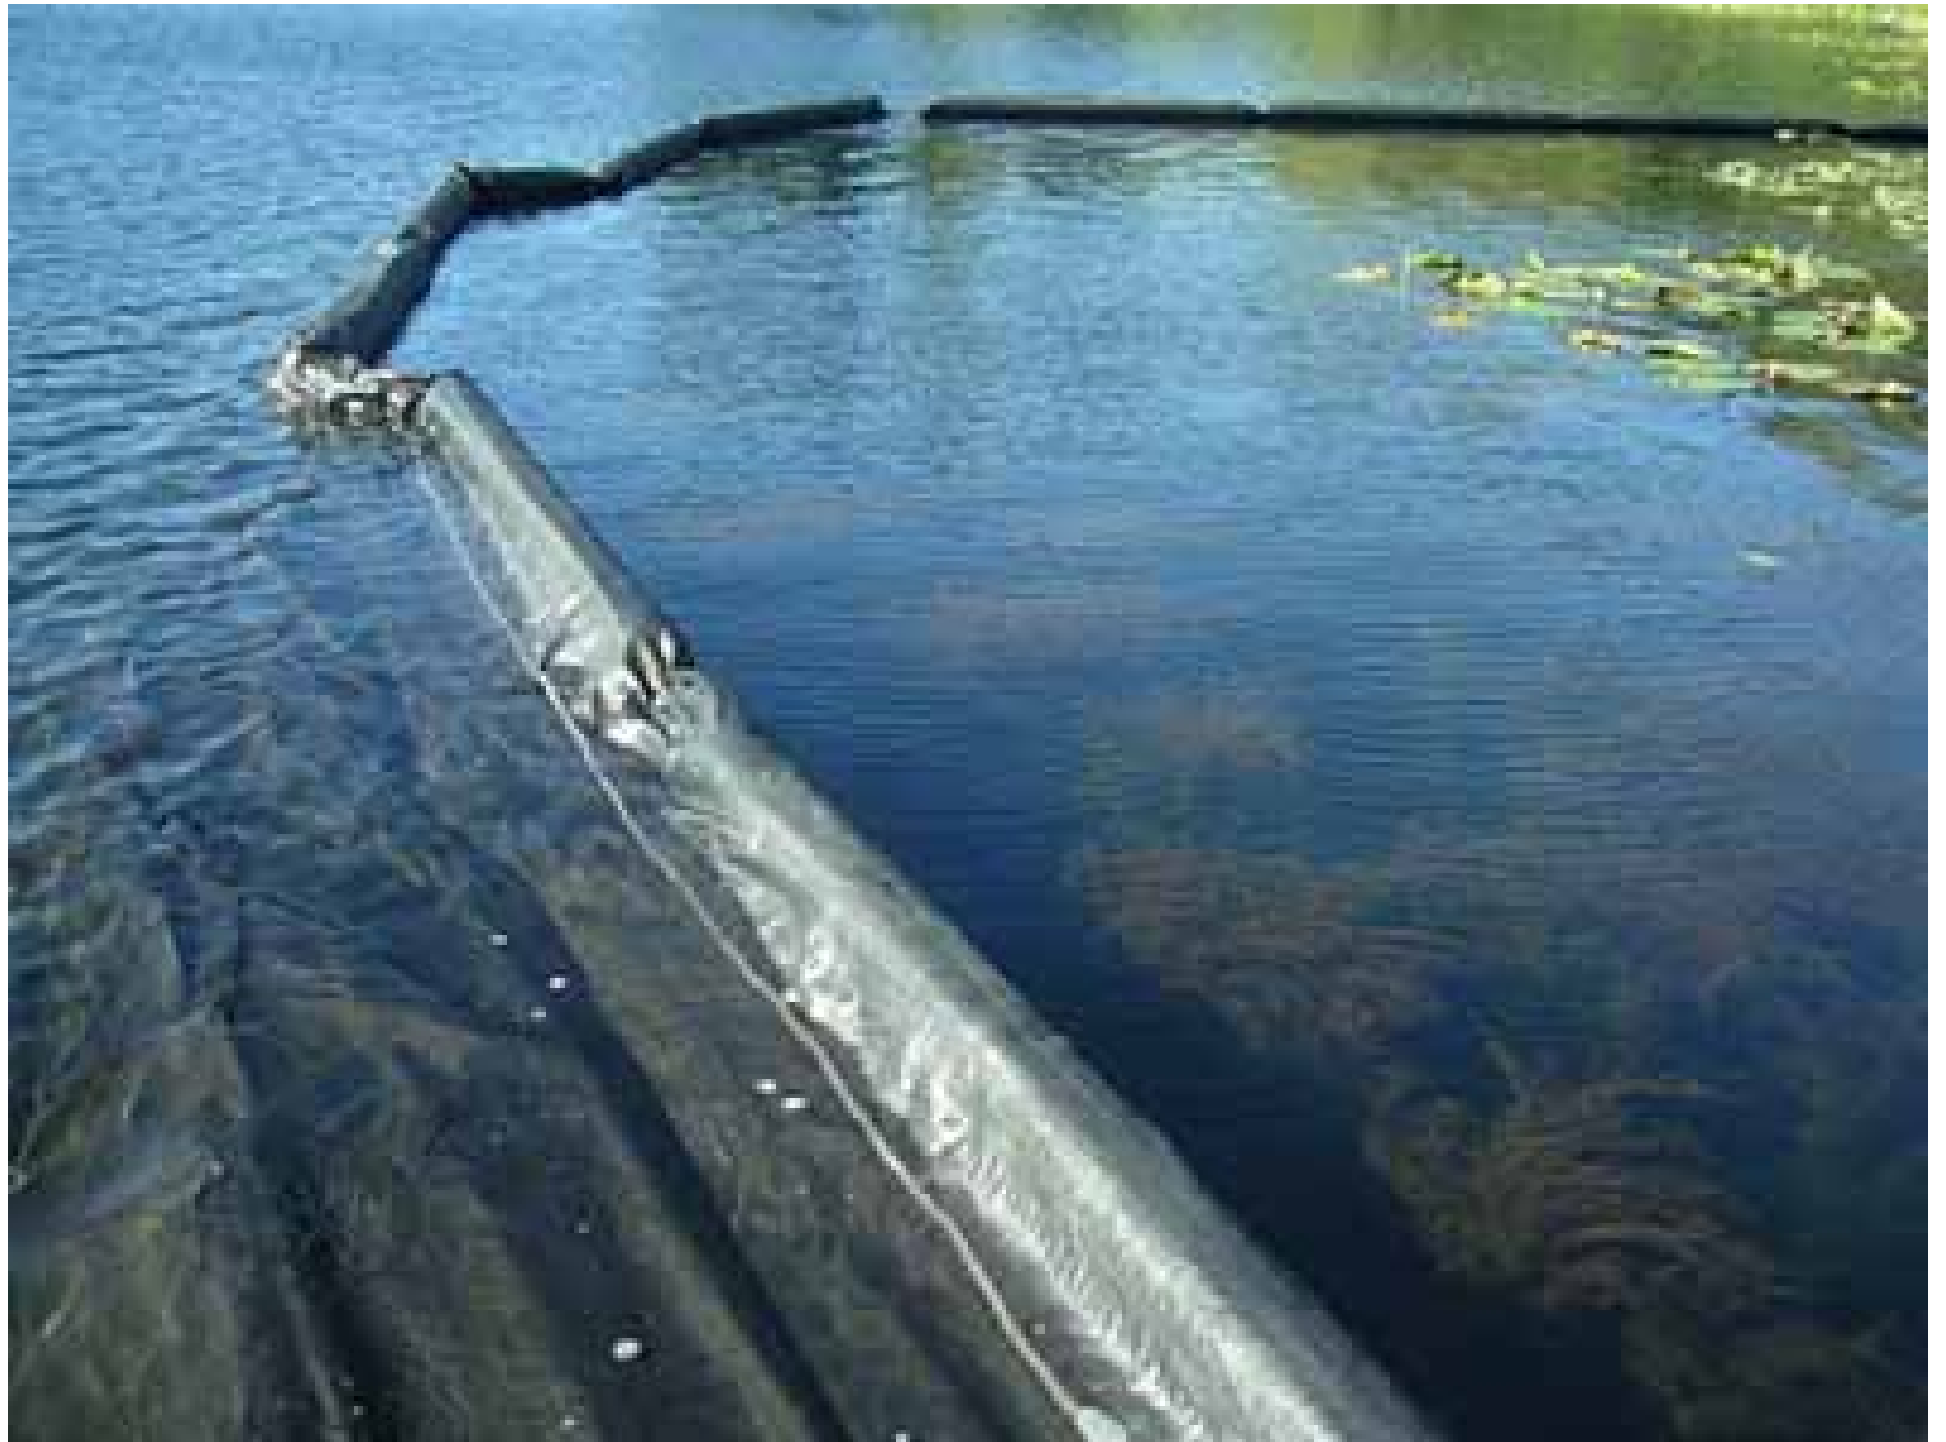
Control

- Contain high-density infestation area.
- Diver pull inside and outside containment area.
- Ongoing diver surveys and control.
 - Success hinges on overlap and redundancy.

Year 1 (2005) results

- Containment area established.
- 580 lbs of milfoil and one 2 pound white water lily removed.
- 4 days, two divers and boat captain.

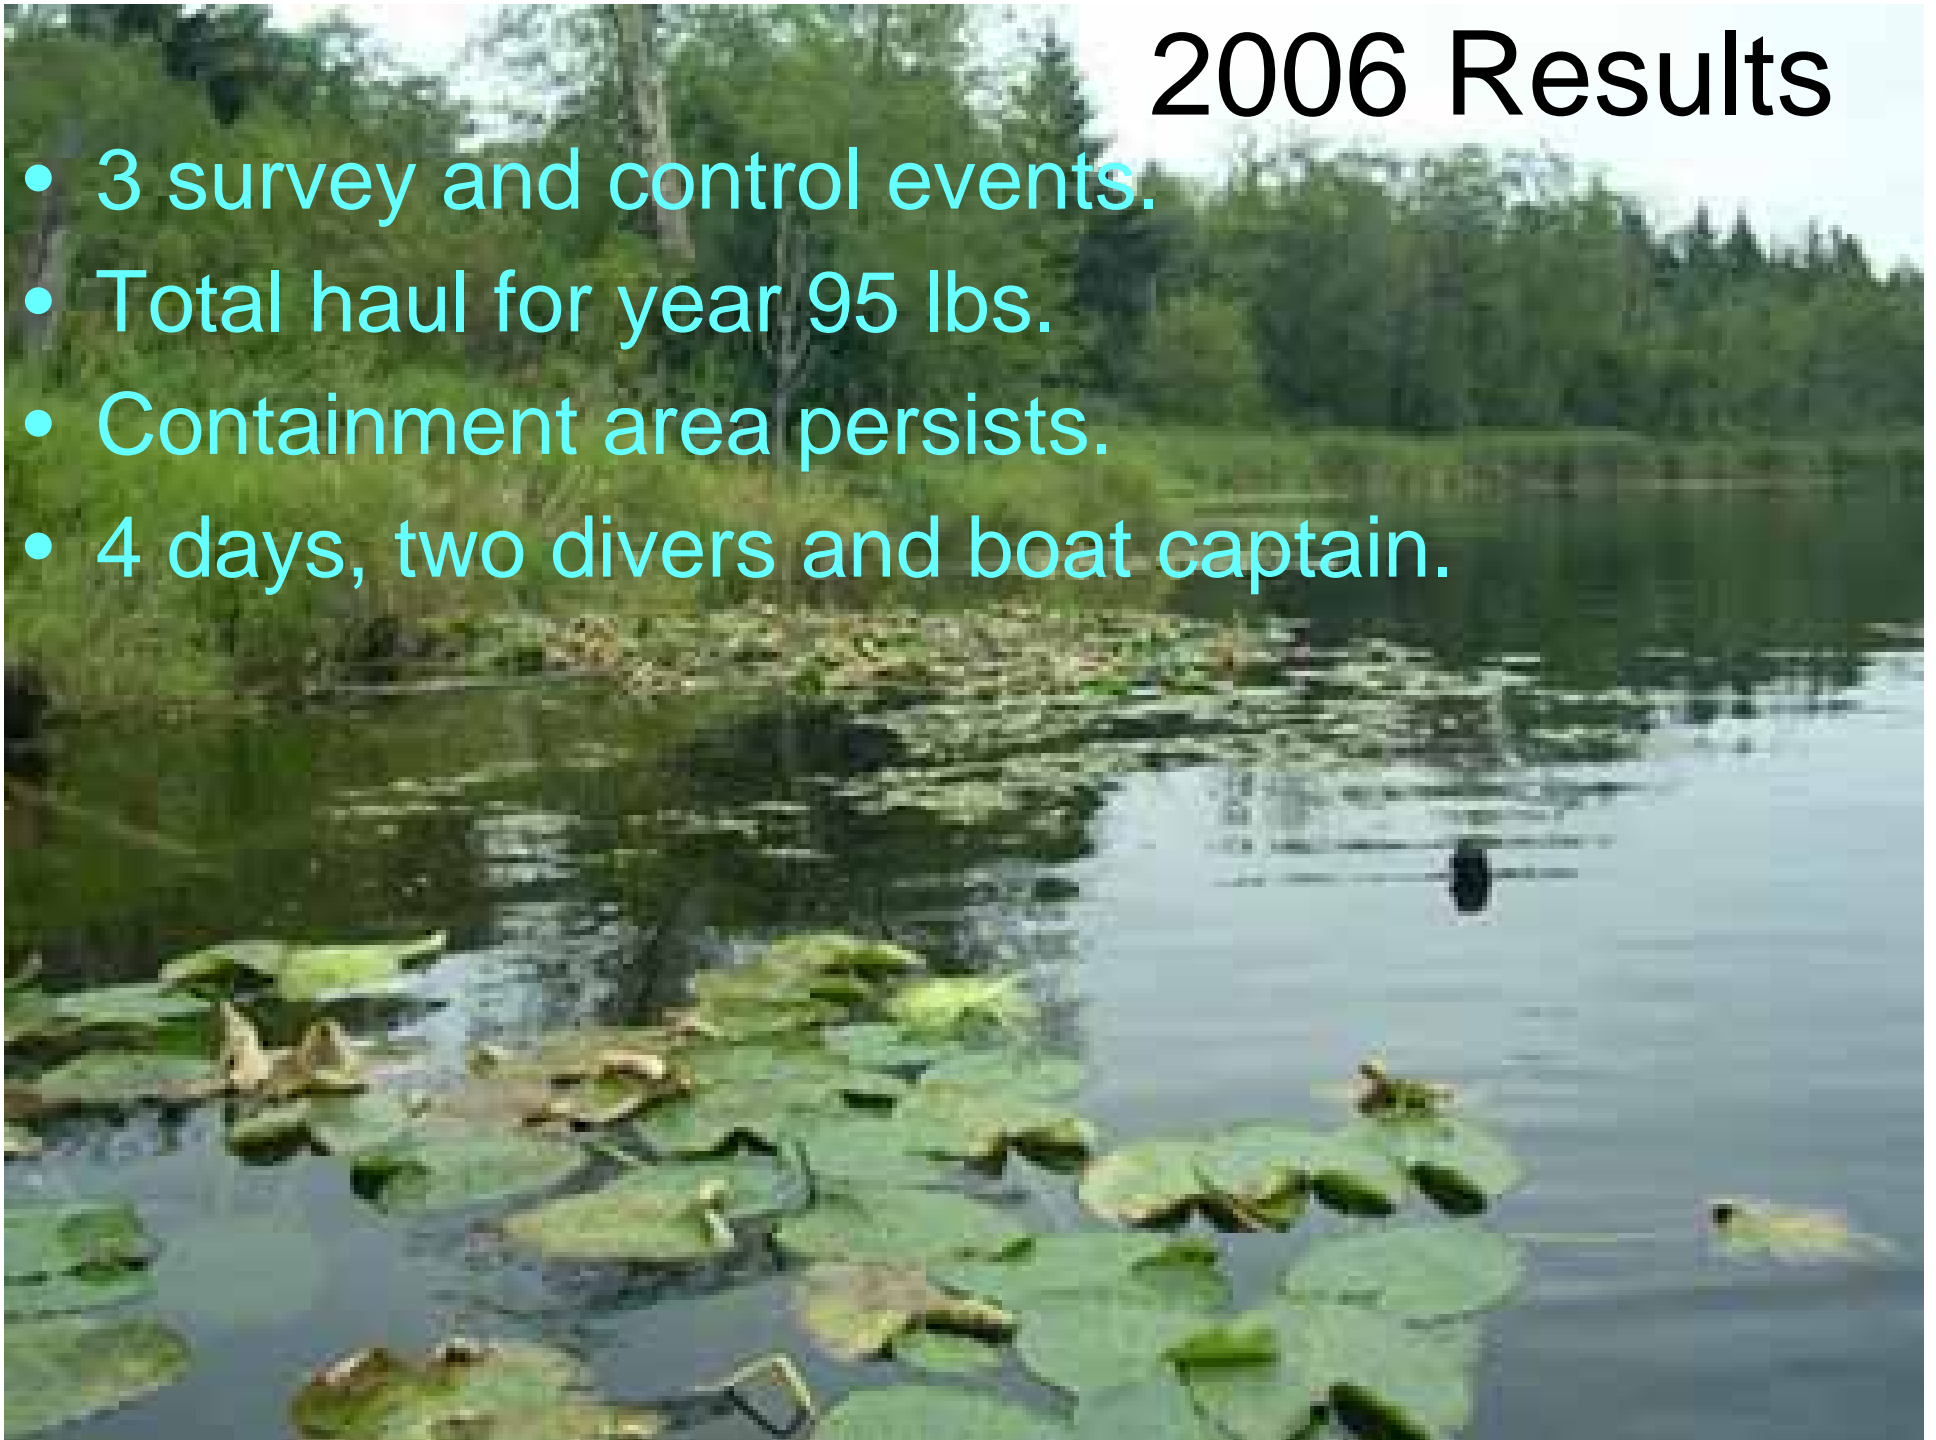
2006 Results

- 3 survey and control events.
- Total haul for year 95 lbs.
- Containment area persists.
- 4 days, two divers and boat captain.
